Visual Streambank Assessment

TOOKANY CREEK WATERSHED MANAGEMENT PLAN

Baeder Creek

Assessed by the Abington Township Steering Committee Members

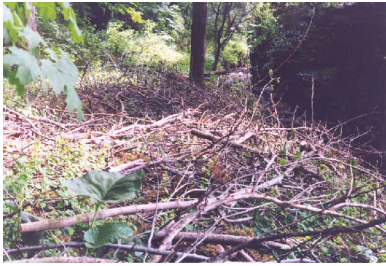
1. Small wetland area on Abington High School property. Storm drain with rip rap.

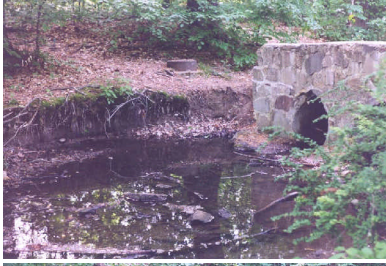
2. Baeder Creek piped under a garage and then under Abington Rd. /Ghost Rd. No water before pipe, on other side of road, water begins to flow. Three storm drains come together under road. For a long stretch, the stream is walled on one side (wood and stone). Other side 50% slope. Lots of brush thrown near stream bed from adjacent properties.

Action/BMP: Homeowner Education program; form local resident creek group to conduct routine clean-ups.

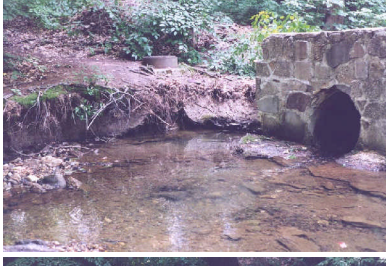
3. Wall on one side continues no slope, straight down on the other side. Small Foot Bridge crosses stream. Two mallard ducks on the stream.

Action/BMP: Stop mowing to the creek banks; Employ Biotechnical streambank techniques to restore bank to a more natural 3:1 slope and replant with native vegetation.

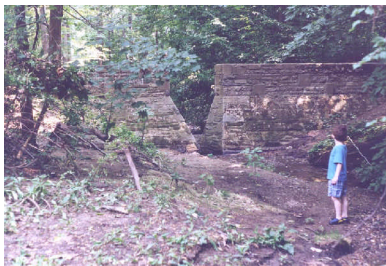
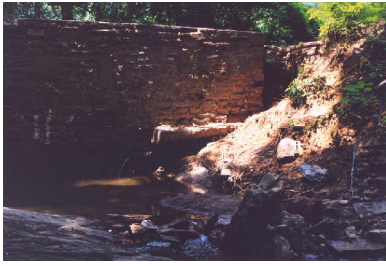
4. Baederwood Park near the creek with foot bridge. Stream widens to 15ft. Small wetland area as indicated by obligate plant species of skunk cabbage. Water clear. Slope 20% on one side, other side wetlands then gradual slope. Under cutting around foot bridge.

Action/BMP: Employ biotechnical streambank techniques to restore bank. After bridge, stream widens considerably in a spot. Bank really cut on side of playground. Action/BMP: Employ biotechnical streambank techniques to restore and stabilize bank.

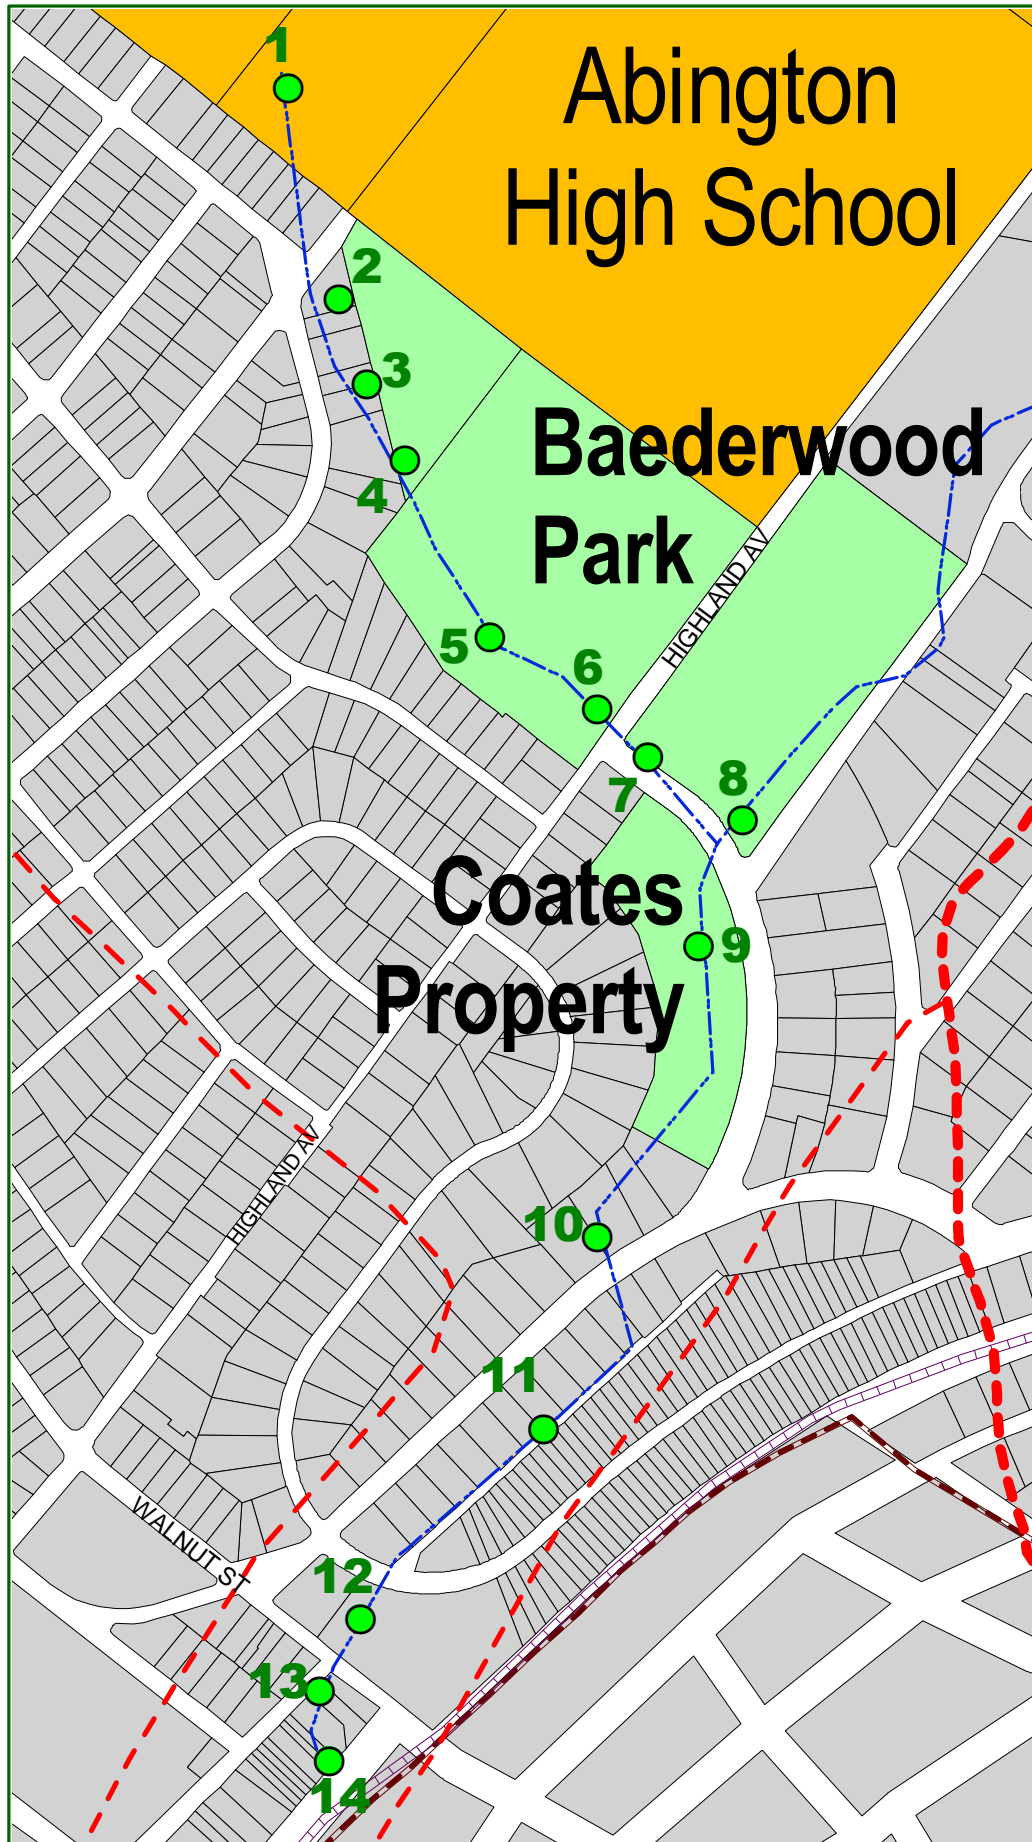
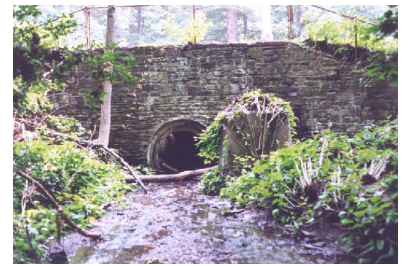
5. Attractive stone wall across the creek, 20 ft high 3ft. gap cut into it - possibly used to slow down water flow. Several mature beech trees, maples, tulip, and oak. A great deal of in-channel erosion.

Action/BMP: Employ Biotechnical streambank techniques to restore bank to repair channel erosion and bring the banks to more natural 3:1 slope and replant with native vegetation

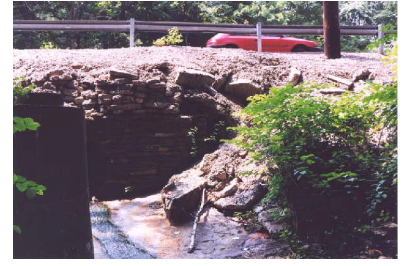
6. Creek flows under Highland Ave. Sewer line in creek bed, undercut. Lots of Knotweed.

Action/BMP: Have Abington Township engineer evaluate sewer line stability and consider biotechnical streambank techniques to repair bank and remove the knotweed with native plants simultaneously.
