# Visual Streambank Assessment

TOOKANY CREEK WATERSHED MANAGEMENT PLAN  
 Township of Cheltenham  
 Rock Creek Watershed

Assessed by the Tookany Creek Watershed Steering Committee Members

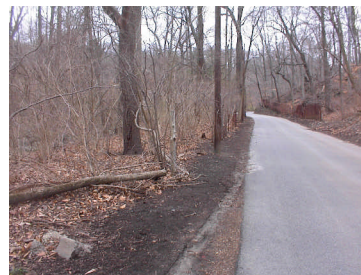
7. From Lorimer Drive to Washington Lane, for 1/3 mile the creek forms the southern border of Curtis Arboretum. The flowing stream regenerates itself. A spring feeds two ornamental ponds in the Curtis Arboretum before emptying into the creek.  
**Action/BMP** : Stop mowing around the spring areas to allow for native vegetation to persist in the riparian buffer to filter the runoff from the surrounding areas.

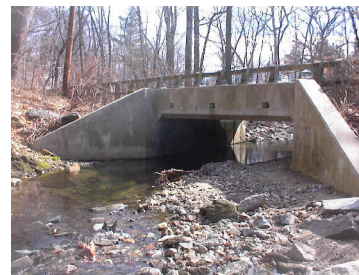
8. For the next half mile from Washington Lane to the Rock Lane bridge, the stream flows through a wooded valley with the lightly traveled Rock Lane close on its southern bank.  
**Action/BMP** : No action necessary; continue to maintain the land uses surrounding this area.
