Visual Streambank Assessment

TOOKANY CREEK WATERSHED MANAGEMENT PLAN

Baeder Creek

Assessed by the Abington Township Steering Committee Members

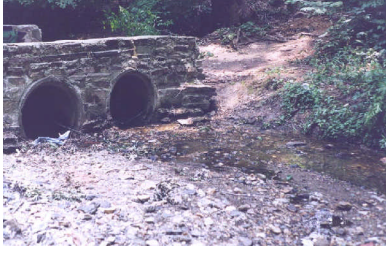
4. Baederwood Park near the creek with foot bridge. Stream widens to 15ft. Small wetland area as indicated by obligate plant species of skunk cabbage. Water clear. Slope 20% on one side, other side wetlands then gradual slope. Under cutting around foot bridge.

Action/BMP: Employ biotechnical streambank techniques to restore bank. After bridge, stream widens considerably in a spot. Bank really cut on side of playground. Action/BMP: Employ biotechnical streambank techniques to restore and stabilize bank.
