# Pennsylvania Stormwater Best Management Practices Manual

# Chapter 9

# Case Studies: Innovative Stormwater Management Approaches and Practices

363-0300-002 / December 30, 2006

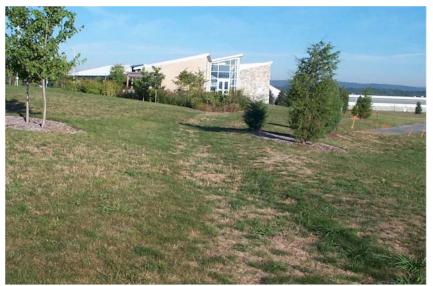
Figure 9-4. Infiltration trench located on contour, State College, Centre County.

The Infiltration Trench (Figure 9-4) intercepts a portion of the entrance road runoff. To compensate for the remainder, a vegetated subsurface Infiltration Bed (Figure 9-5) was located immediately adjacent to an existing, uncontrolled parking lot.

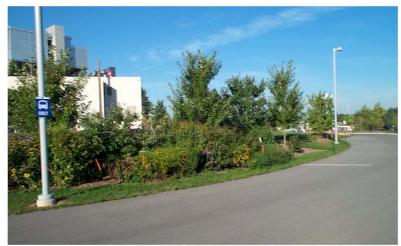
Figure 9-5. Vegetated infiltration bed, State College, Centre County.

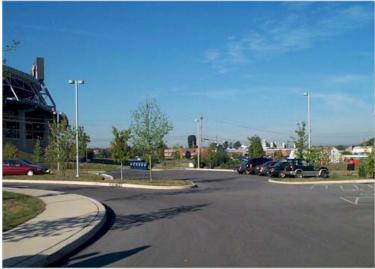
Figure 9-6. Porous asphalt parking lot, State College, Centre County.

The runoff from the western portion of the building is conveyed to the parking lot immediately adjacent to the building where the soil mantle is suitable and the top of bedrock was much deeper (Figure 9-6). In several key locations where stormwater management was needed, small Rain Gardens (Figure 9-7), designed to infiltrate, were incorporated to avoid installing stormwater pipes.

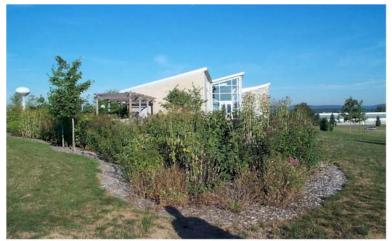
Figure 9-7. Rain Garden, State College, Centre County.

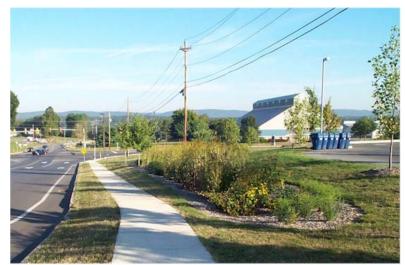
Figure 9-8. Porous concrete sidewalks, State College, Centre County.

Porous concrete sidewalks were constructed to manage the rainfall incident to them (Figure 9-8).

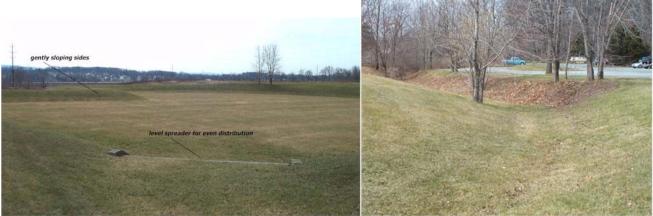
Figure 9-12. Level spreader distributes stormwater into the infiltration basin.

Figure 9-13. Vegetated swale

The <u>vegetated infiltration basin</u> (Figure 9-11) collects stormwater runoff from one parking lot and one building, and mitigates runoff from two additional buildings nearby. The basin was designed with a high loading rate of impervious surface runoff to BMP area. Stormwater runoff sheet flows from the inlet to a <u>concrete level</u> <u>spreader</u> (Figure 9-12) into the infiltration basin. The surface of the infiltration basin was graded with extreme care, creating an even basin surface elevation to receive stormwater. Figure 9-13 shows the <u>vegetated swale</u> inflow to the infiltration basin.

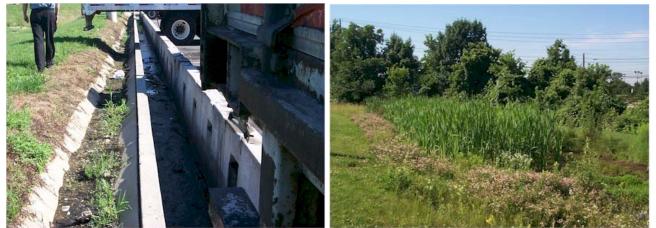
Figure 9-16. Perimeter trench drain.

Figure 9-17. Vegetated infiltration filters.

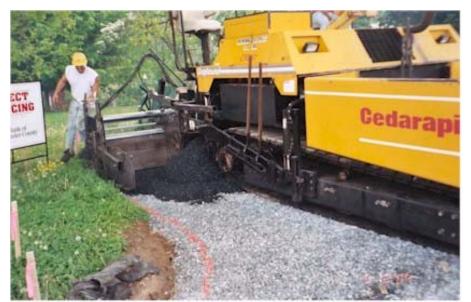
Figure 9-22. Construction of porous asphalt parking area to compliment building expansion.

The porous parking is underlain by a stone infiltration bed with various benches ranging in depth from 18 to 48 inches and receives runoff from surrounding impervious driveways and parking areas. The bed connected to the northernmost parking row is designed to overflow to a flat grassed area, and the bed under the southern row discharges to a vegetated bioretention swale. As part of the design, a portion of the existing impervious parking area was removed and a bioretention bed was installed to promote the additional infiltration of runoff conveyed by the existing parking areas.

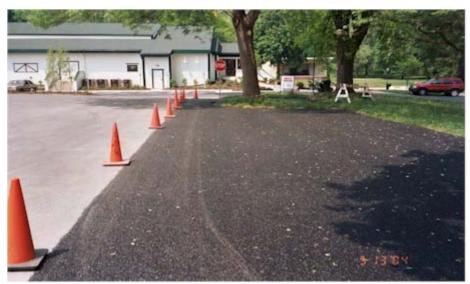
Figure 9-23. Completed porous asphalt parking lot at Ephrata Performing Arts Center.

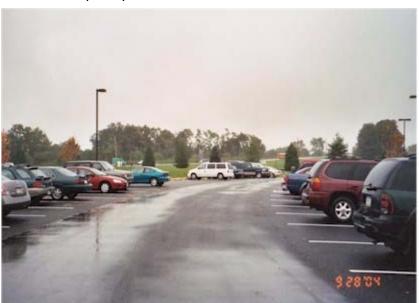
Figure 9-24. Completed porous asphalt parking lot at Lebanon County Conservation District.

The porous pavement parking lot was installed on an existing lawn area and is underlain by a 24 -inch infiltration bed. The bed was excavated and unwoven geotextile fabric was placed on the undisturbed subsoil. Clean AASHTO #1 aggregate was placed in the bed in 12-inch lifts and lightly rolled to prevent settling. Finally, a 3-inch choker course comprised of AASHTO #57 was placed over the larger aggregate and was finish graded to prepare for the asphalt pavement.

The porous parking receives runoff from the center drive lane, which was constructed with conventional asphalt. The overflow design is comprised of four 4-inch pipes placed at the top of the infiltration bed and discharging to a well-vegetated area. Two 6-inch pipes, which discharge to an existing vegetated swale on the site, provide additional overflow. The project site has been observed during several high intensity storms and appears to be working successfully as there was little or no discharge apparent from the overflow pipes.

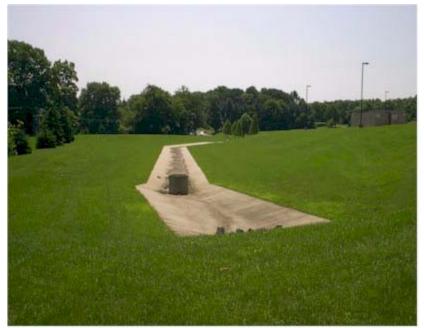
Figure 9-25. Existing sinkhole-plagued detention basin.

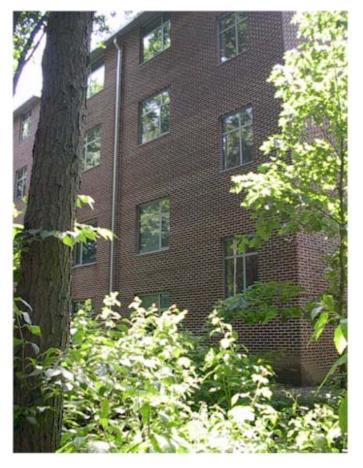
Figure 9-26. Example of minimum disturbance and prevent erosion or disturbance on the hillside.

to the plan was the repositioning of the new dormitories in a more organic fashion along the contours in the woods. This sensitive positioning preserved healthy trees and minimized earth disturbance, which was limited to within 15ft of the new structures. Another major improvement was relocating the new parking lot away from existing woods and into the meadow. Also, this parking lot was constructed with porous asphalt and underlain by an aggregate infiltration bed.

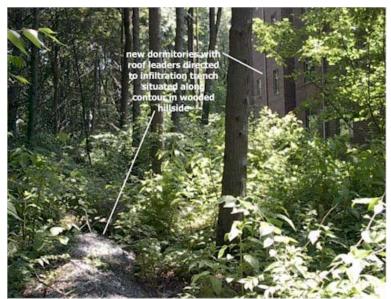
Figure 9-27. Level spreader pipe/infiltration trench in woods.

The stormwater management plan for the developed site was a great improvement over the existing condition. Stormwater management for new dormitories consisted of an aggregate infiltration trench beneath a standard asphalt walkway "interior" of the complex and "exterior" level spreader perforated pipes along contours in the woods. Roof leaders on the interior halves of the dormitories were connected to the aggregate trench/walkway. (These walkways were stabilized beyond the standard asphalt by a "grass pavement" for fire truck access.) Likewise, roof leaders on the exterior halves were directly connected to the level spreader perforated pipes in the woods. These laterally extending pipes were designed to maintain soil moisture for the woodlands.

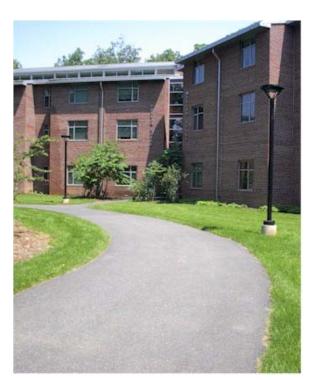
Figure 9-28. Standard asphalt walkway w/ subsurface infiltration trench.

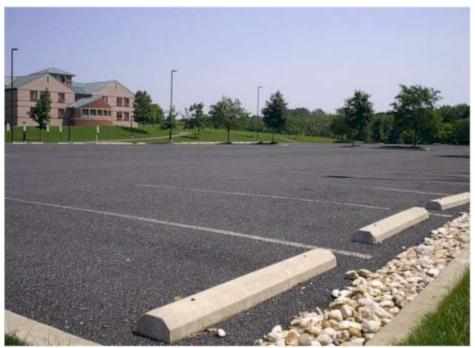
Figure 9-29. Porous asphalt parking lot with subsurface infiltration bed.

The new porous asphalt parking lot was designed to mitigate incident rainfall and direct runoff from the nearby access road and existing dormitories. The porous parking lot has so far effectively discouraged the concentration of stormwater runoff downhill and allowed the incident rainfall to pass directly through the parking bays, slowly percolating into the soil and recharging the aguifer system. This system has also dramatically reduced discharges to the existing sinkhole-plagued basins. To date, neither the porous parking lot nor the existing basins have experienced additional sinkhole problems. Furthermore, polluted runoff from the site, usually described as nonpoint source pollution (NPS), was significantly removed by the overall plan. The new improvements at the PSU Berks County campus have had virtually zero impact on regional water resources.

The cost of the new porous asphalt parking lot with subsurface aggregate infiltration bed came to around \$1100 per space, in 1999 dollars. When all related site work (lighting, landscaping, erosion and sedimentation control, etc.) was considered, the final cost per space was around \$2200, also in 1999 dollars

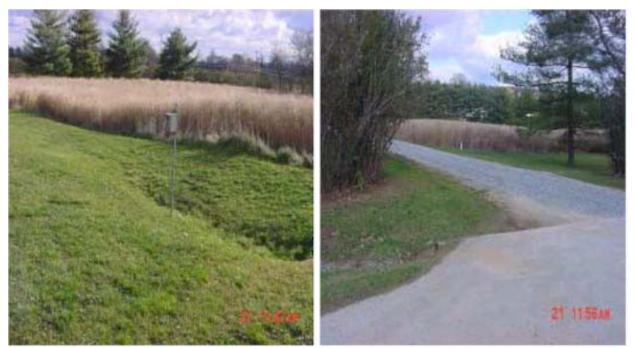
*Figures 9-30 & 9-31. Warm season native grassy meadows established at this site provide greater stormwater infiltration opportunities than maintained turf grass fields. Low maintenance meadows enhance wildlife habitat.*

Establishing warm season meadow of native grasses is included in this manual as a BMP because the overall environmental performance of unmowed, unmaintained native grass meadows is superior to that of mowed and maintained turf grass fields, both in terms of stormwater quantity and stormwater quality. Meadows promote stormwater infiltration into the ground; through interception of any stormwater flow (sheet or channelized), rate of flow is slowed. Periodic application of fertilizers and herbicides is eliminated; therefore chemical pollution to surface runoff as well as to the groundwater is reduced. Native grasses also have a greater potential to uptake any pollutants present in stormwater runoff, in contrast to conventional turf grass, although no pollutant reduction analysis specifically has been performed for this BMP project. To a large extent, sediment and grit, oil and grease, as well as nutrients present in site stormwater runoff will be filtered by the natural biological and physical filtration processes provided by native meadow grasses prior to being discharged into receiving waters or being percolated deeper into the groundwater. Additionally, established warm season grassy meadows provide natural open space habitat and are especially attractive to wildlife, including birds.

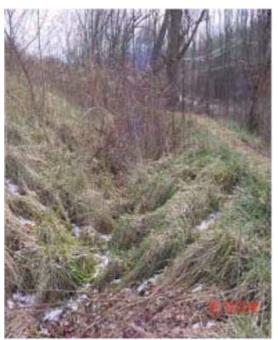
*Figure 9-34.* Narrow, vegetated infiltration trenches/berms follow land contours and take on a naturalized appearance.

At the encouragement of the Township and its Municipal Engineer, an integrated system of berms and infiltration trenches was constructed. The typical berm/trench consisted of narrow, elongated, surface depressions created by built up earthen embankments, or berms, that promote stormwater infiltration. At this site, the infiltration trenches are elongated, shallow trenches on the surface that collect and temporarily store stormwater runoff from the upslope residential lots and streets and promote its infiltration (in contrast to sub-surface, excavated, fabric-wrapped, stone-filled trenches as described in Chapter 6). Stormwater that collects in these narrow depressions on the hillside gradually seeps through the soil into the ground and eventually into the creek and water table below. These berms/trenches follow the contours of the land in a parallel sequence. There are three 400 foot-long trenches terraced, or stepped, down the slope with one below another.

When the uphill trench is filled to capacity, stormwater overflows into the trench below. There is also a single 1,000 foot-long trench that functions independently of the three terraced trenches. This large trench receives stormwater through a subsurface pipe. Because stormwater entering this trench is conveyed through a pipe with a steep slope and has high velocity, a concrete chamber is used to dissipate its energy before discharging into the trench. When this trench overflows, stormwater spills over its downslope berm and flows down the bank into the stream below. For an infiltration trench to properly function, the bottom soil must be permeable and remain uncompacted for the life of the structure. Soil percolation tests performed prior to trench construction and at the conclusion of earth disturbance are used to ensure soil infiltration capacity. Vegetation has naturally established itself in the trenches. The berms, which double as a walking path, consist of a gravel and grassy base and are wide enough to permit access for future maintenance of these structures.

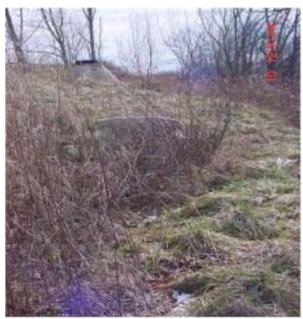
Figure 9-35. This trench/berm has a subsurface energy dissipater to reduce the velocity of entering stormwater.

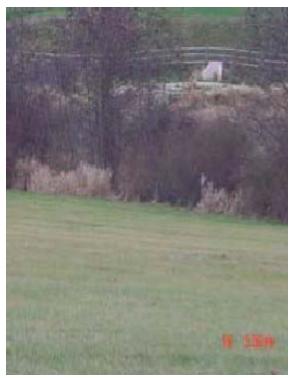
site, stabilize flow, and *Figure 9-36. Constructed wetland in background.* provide valuable habitat opportunities.

The most significant BMPs constructed as part of the strategy were a constructed treatment wetland and two wet ponds. Other stormwater measures at the golf course included grass swales, fertigation (fertilization and irrigation), cold-water discharges, and open space donation. The constructed treatment wetland at the site was designed primarily with water quality objectives in mind. It was constructed in a low-lying area near natural wetlands in the Ridley Creek floodplain. This allowed it to take advantage of inflows of water between storm events and to maintain sufficient soil moisture. Through physical. biological, and chemical processes, constructed wetlands can efficiently remove a great many contaminants commonly found in runoff (suspended solids, nutrients (nitrogen and phosphorus), heavy metals, toxic organics, and petroleum compounds). Wetland vegetation, algae, and bacteria allow for the biological uptake of contaminants. Wetland vegetation also provides physical and chemical pollutant filtering mechanisms, which greatly enhance the quality of the runoff from the golf course, as well nearby residential development. Constructed wetlands also play a role in reducing peak rates from a

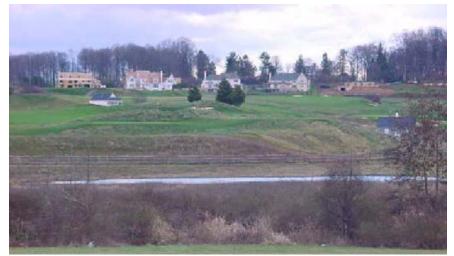
Figure 9-37. Large pond, constructed wetland, managed and naturalized areas of golf course.

A wet pond is a stormwater management feature that maintains a permanent pool of water (retention) and has additional capacity for stormwater detention. Two wet ponds were constructed at the golf course as part of the improvements. The smaller of these two wet ponds has the preferable elongated shape, while the larger is comprised of two cells. When the first cell has reached capacity, water spills over into the second cell. The larger pond receives treated wastewater from a nearby, township-owned wastewater treatment facility. Water is pumped from this pond and used in the site's fertigation system.
